Manhole Inspection Summary

Manhole # S29M__028MH

Location Address: **I 395 N (mile marker 14N)**

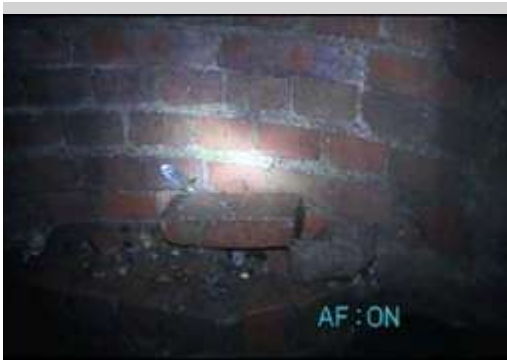
Miscellaneous

debris on bench

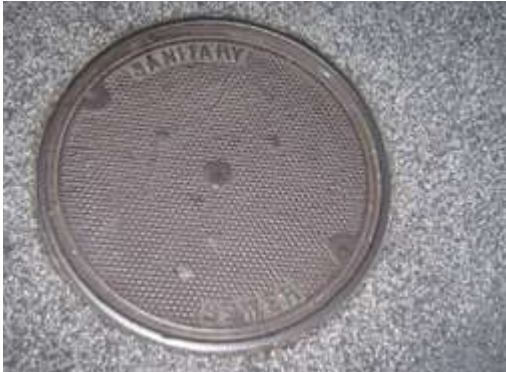
Miscellaneous

mh cover

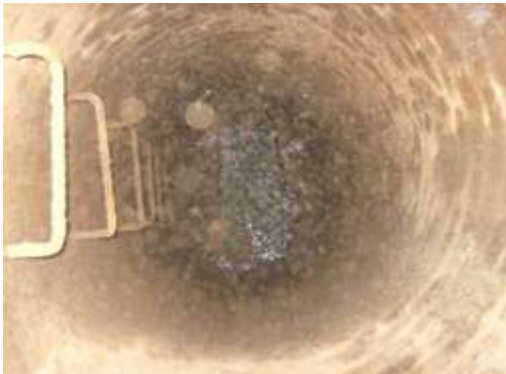
Defect 1

Count: **10** Missing: **0** ☒ **Corroded**

corroded steps

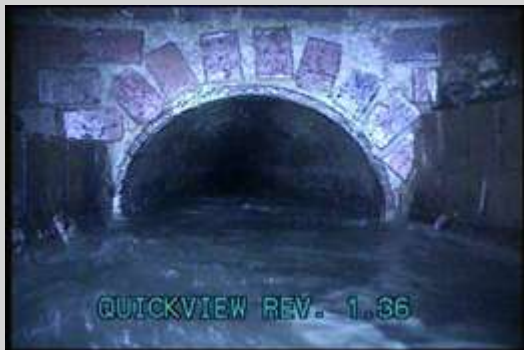
12 O'Clock Outflow

15 in. Circular Gravity Sewer
Pipe Out @ 12 O'Clock

Pipe Height: **15.6** (in.) Rod and Bar (Angled)
Pipe Material: **Clay** ☐ Pipe Lined
Invert Depth: **16.50** (ft.) Flow Characteristics: **Fast**
Deposits: ☒ None ☐ Mud ☐ Sludge ☐ Debris ☐ Grease
Silt Depth: **0** (in.) Deposits Extent:
Infiltration: **None** Pipe Seal Cond: **Sound**

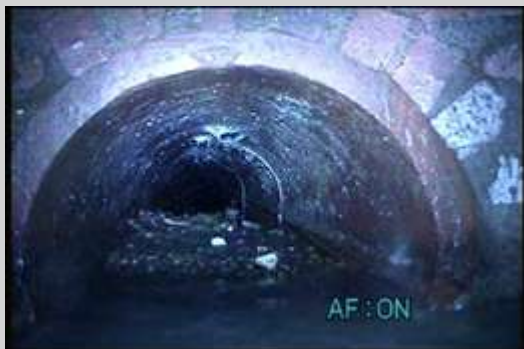
4 O'Clock Inflow

12 in. Circular Gravity Sewer
Pipe In @ 4 O'Clock

Pipe Height: **12** (in.) Rod and Bar (Angled)
Pipe Material: **Clay** ☐ Pipe Lined
Invert Depth: **16.10** (ft.) Flow Characteristics: **None**
Deposits: ☐ None ☐ Mud ☐ Sludge ☒ **Debris** ☐ Grease
Silt Depth: **0** (in.) Deposits Extent: **Light**
Infiltration: **None** Pipe Seal Cond: **Sound**

Connects To: **Stub connection / abandoned**

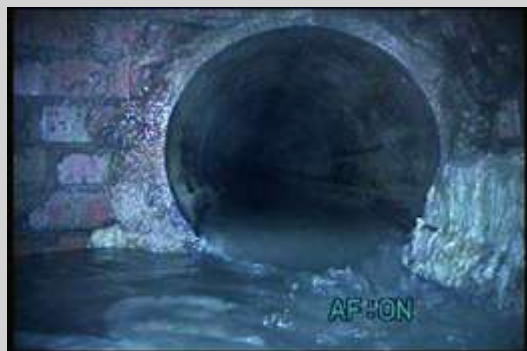
6 O'Clock Inflow

12 in. Circular Gravity Sewer
Pipe In @ 6 O'Clock

Deposits: ☒ None ☐ Mud ☐ Sludge ☐ Debris ☐ Grease

Infiltration: **None** Pipe Seal Cond: **Sound**
